CONSIDERATIONS ASSOCIATED WITH THE TESTING OF EXTERNAL PIPELINE COATINGS

D. Abreu¹, M. Y.J. Tan¹, A. Bryson³, A. Fletcher⁴, G. Cope⁵, G. Pearson⁶

SUMMARY: Reliable testing methodologies for the assessment of protective coatings are critical for ensuring the integrity and durability of pipeline coatings (such as field joint coatings) and the mitigation of pipeline corrosion. Currently the failure of joint coatings is one of the major concerns in corrosion protection of pipelines, although they represent only approximately 5% of the coated area in a pipeline system. This paper presents an overview of major testing methodologies currently used in the pipeline industry for the selection, testing, and life prediction of coatings, in particular field joint coatings. Particular focus is on the discussion of difficulties and limitations in testing methods for assessing pipeline coating cracking, cathodic disbondment and loss of adhesion. It is shown that there are limitations in current methodologies in evaluating the coating flexibility - a key parameter for avoiding coatings cracking during hydrostatic testing, cyclic pressure operation and field bending. Methodologies for assessing th

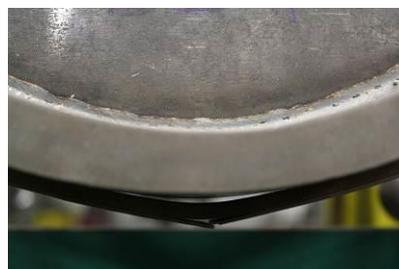
Figure 4 “Peaking” occurred when a mandrel is pressed on a specimen of 5 mm of steel coated with FBE.

It was decided to build equipment for 3 point bending tests. A set of mandrels of different diameters were built and coupons of 25 mm x 200 mm x 5 mm coated on different thickness were tested. Aiming to evaluate the difficulties associated with this test, some important observations can be made. Firstly, there is a difficulty associated with this type of bending system, where “peaking” was observed, even on larger diameter mandrels, Figure 4. The problem of this “peaking” is that these regions experienced a much higher level of strain, resulting in cracking occurring prematurely due to the high strain concentration on the centre of the coupon. This effect was confirmed on strain gauges measurements and simple computational analysis, Figure 5. The Standard BS EN10290:2002 [31] identifies this problem and give the orientation to disregard the results on the central region if a “peaking” is presented. This problem has been recognised in the coatings industry and ways to eliminate the problem have been developed. Following the advice of an industry partner, clamps were used to hold the coupon tightly against the mandrel during testing. This prevented any peaking and resulted in much more consistent results and a much more uniform application of strain to the coating under test, as shown on Figure 6. Another issue associated with this test is cracks that might occur during over-bending. When the side of the inner mandrel comes in contact with the sample, increasing sharply the strain on that region it can become wedged between the inner and outer mandrels, leading to not representative cracks. The solution in this case is to avoid this over-bending by stopping the bending process before it can occur.

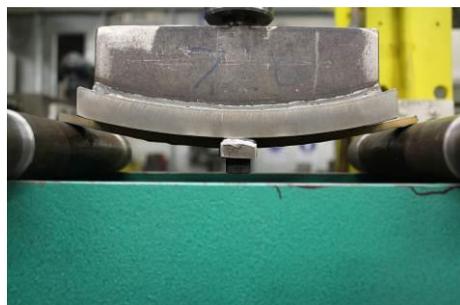
Figure 6 Solution for the “peaking” on samples using clamps.

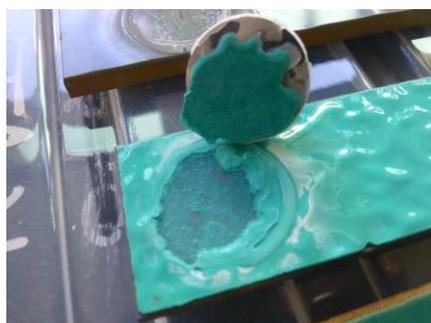
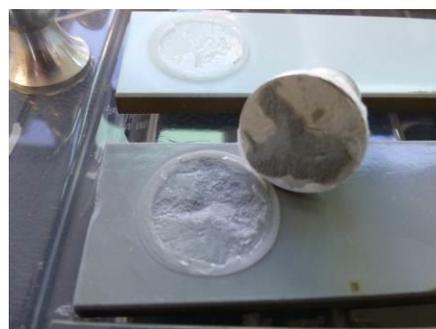
Figure 8 Adhesion test result: (a) Loss of adhesion; (b) Loss of cohesion.

This work evaluated results of adhesion tests performed based on the standard test method ASTM D4541-09 [40]. The pull-off force for coating-steel adhesion measurement can be measured using a specific system as described in Annex A4 of the standard. An automatic pull-off adhesion tester was used for this work. Table 5 shows the results obtained. The dollies used had a diameter of 20 mm and the adhesion strength was calculated from the force measured. The same procedure was used on samples after 24h hot water immersion, as described on the standard test method AS/NZS 3862:2002 [33] Appendix B Table B3, resulting in another group of samples for the test. The glue used for attaching the dollies to the coatings was the one proposed by the equipment manufacturer and the dollies were 20 mm in diameter. Figure 8 (a) presents a loss of adhesion after the pull off adhesion test while Figure 8 (b) presents a loss of cohesion.

It can be observed that the adhesion strength was lower for the samples submitted to hot wet immersion, except for the Type D coating which had a similar extraction force. The sample Type A that was not submitted to preconditioning was the unique sample where there was a real loss of adhesion on the interface coating-substrate. All other changes occurred as a loss of cohesion either within the coating or associated with the glue. For the samples Type A and Type B, the preconditioned ones presented lower loss of adhesion but detached on lower forces. One possible conclusion is that the preconditioning caused a loss of cohesion on the coatings. However, for all other types, the loss of adhesion occurred at the glue / dolly / coating boundaries indicating that the glue was inadequate for these high levels of stress. Two other types of glue were used for this test and the adhesion between the glue and the coating were even lower.
