# QUANTIFYING THE EFFECTS OF MAJOR FACTORS AFFECTING THE EFFECTIVENESS OF CATHODIC PROTECTION OF PIPELINES

**SUMMARY:** Cathodic protection (CP) is widely applied as a principal means of protecting buried steel pipeline from soil corrosion. Unfortunately in practice the potential of a buried steel pipeline could be diverted from the standard 'safe' CP level (i.e. -850 mV vs copper/copper sulphate reference electrode) due to various reasons such as stray currents, flawed CP design or faulty CP control, leading to insufficient CP (in cases of anodic potential excursions) and over-protection (in cases of excessive negative potential excursions). This problem can be further complicated when the potential fluctuates due to complex forms of external electrical interference signals that may be direct current (DC), alternating current (AC) or AC superimposed on DC in nature. Some forms of potential excursions are known to be harmful to buried steel pipelines; however currently the exact effects of potential excursions on CP efficiency and corrosion have not been sufficiently understood preliminary due to difficulties in measuring these effects. Over-protection is known to cause cathodic d

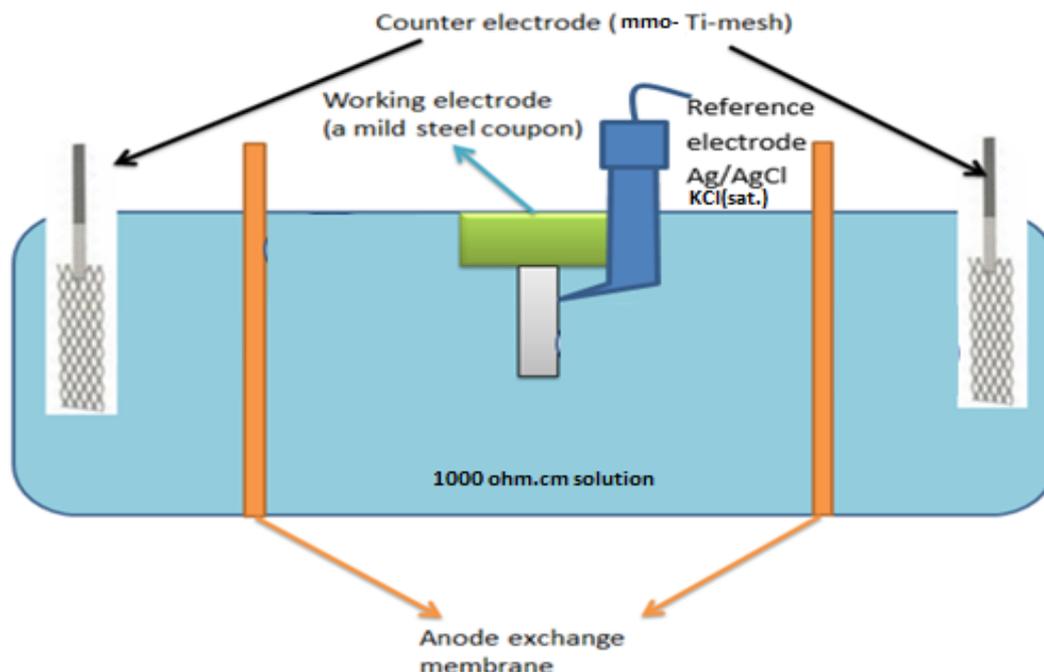
Figure 1 Novel aqueous cell for simulating and measuring soil corrosion under CP excursions.

CP excursions test results; however initial trial using an aqueous corrosion cell was not successful, because of the mixing up of  $\text{OH}^-$  and  $\text{H}^+$  ions from anodic and cathodic reactions, and failure of simulating true high pH conditions over CP protected surfaces. In order to better simulate the pH environment on steel surface, a novel electrochemical cell, as shown in Figure 1, has been designed by utilising an electrolyte that mimics the high resistivity of soil and an ion selective membrane that separates the electrolytes in the anodic and cathodic zones. The membrane avoids pH changes due to the mixing of solutions from the anodic and cathodic zones, while maintaining conductivity to ions in the electrochemical cell. The improved experimental method exhibited expected CP behaviour with high pH value recorded in the cathodic zones and lower pH recorded in the anodic zones. This experimental setup was further enhanced by improving uniform current distribution using multiple CP anodes. Electrolytes of 1000 ohm.cm resistivity have been selected as ‘baseline’ moderate corrosive media which are appropriate for completing accelerated corrosion tests in a relatively short period of time. The predesigned ‘baseline’ CP excursion signals are  $\pm 250$  mV sine wave superimposed on the standard CP potential of  $-850$  V<sub>CSE</sub> with 1 cycle per minute. It has been shown that this new corrosion cell is able to simulate the conductivity, pH and CP excursion conditions over a bare pipeline surface. It also enables in-situ observation of accelerated corrosion processes and patterns, and the correlation of corrosion behaviour with different forms of potential excursions over various experimental periods. Steel corrosion as a result of several selected forms of CP excursions has been categorised and quantified using this aqueous corrosion cell under simulated energy pipeline environmental and cathodic protection conditions. As shown in Figure 2, after 15 days of testing in the cell shown in Figure 1, the corrosion behaviour of these specimens indicated localised corrosion with a few pits observable on the steel coupon surface with standard CP potential of  $-850$  mV vs. CSE applied for the first 24 hours and  $\pm 250$  mV sine wave excursion from the  $-850$  mV vs. CSE with 1 cycle per minute applied on the steel specimen for the next 14 days. This behaviour is similar to that observed on practical buried pipeline surfaces under CP. Corrosion pattern and rates were found to change significantly with varying CP excursions signal amplitudes ( $\pm 250$ mV and  $\pm 500$ mV), CP potential levels ( $-850$ mV and  $-900$ mV vs CSE) and pH conditions. It is clear that localised corrosion rates are much higher than general corrosion rates. Corrosion rate results from surface profilometry analysis and from Faraday’s law calculation are similar in most cases if only general corrosion rates on general surface area are considered. Using the electrochemical setup described above, the pH of the cathodic zones was maintained at a relatively high pH value (above 9) while the anodic zones had a low pH value (around 3). Although the pH values and distributions may not fully simulate the buried pipeline CP system yet, they still produce a passive condition and corrosion behaviour similar to that observable on buried pipeline surface, ie. localised attack. This experiment also confirms the critical effects of the surface pH value on steel corrosion behaviour and needs further investigation with respect to its interplay with stray currents. More details on this new aqueous testing cell have been presented elsewhere [18].

Although the aqueous corrosion cell shown in Figure 1 is very useful in fundamental research of stray current corrosion, eventually it does not fully simulate soil and field conditions, especially the pH and oxygen and ions diffusion conditions. Therefore experiments have been further extended from an aqueous corrosion cell to a sand corrosion cells. Various forms of soil and clay cells have been designed in order to achieve upscale of the lab testing of pipes subjected to CP excursions in buried environmental conditions. A typical sandy soil cell experimental setup is shown in Figure 3. The medium in the soil test was 1000 ohm.cm sandy soil. The resistivity was adjusted by a 0.5mol/L NaCl solution. The whole cell was sealed to preventing evaporation during the experiment period. The testing cell parameters are the same as the aqueous cell, except that no membrane was needed in this sandy soil cell. In a typical test, a pre-designed interference signal of  $\pm 500\text{ mV}$  on CP  $-850\text{ mV}_{\text{CSE}}$  was applied to a steel specimen, after a constant CP of  $-850\text{ mV}$  vs CSE was applied to it for 24 hours. After 15 days test in the sandy soil cell, as shown in Figure 3, localised corrosion occurred on the coupon surface. Our test results suggest that pH condition over a simulated pipeline surface is critical in corrosion behaviour. Under high pH conditions, the steel coupon surfaces were passive. Although this passive film can reduce general metal dissolution, it can lead to localised corrosion when a large interference signal, e.g.  $\pm 500\text{ mV}$ , was imposed on the steel surface. This result also suggests that the aqueous corrosion cell of its current design could only mimic several features of the sandy soil cell. Therefore our current tests are carried out in both aqueous and soil cells to take advantage of both testing cells.

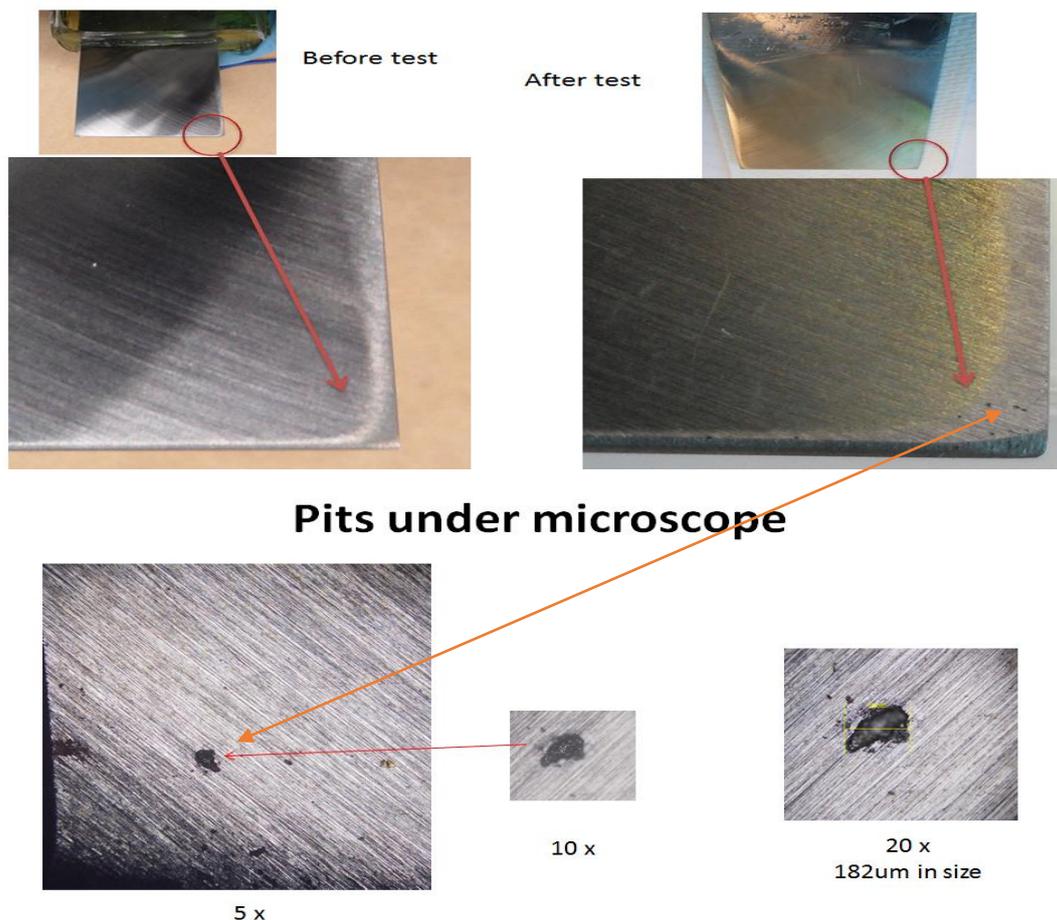
Figure 2 Localised pits observed over the coupon surface after 15 days of test. The surface was cleaned with Clark solution before microscopic observations.

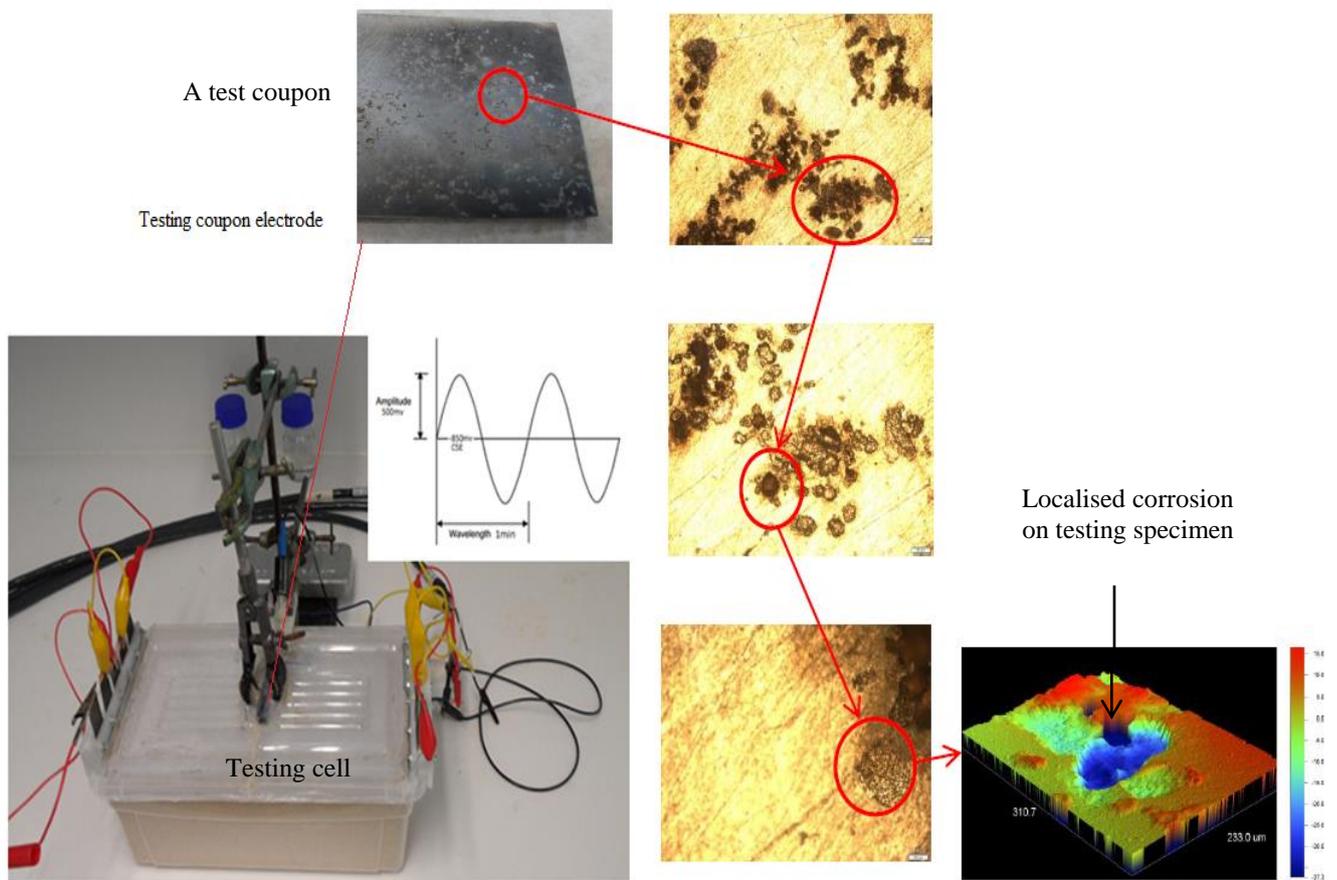
Figure 3. A new sand box electrochemical cell designed and applied to categorise and quantify the level and nature of damage as a result of various modes of CP excursions, and a coupon after 15 days test in the soil sand box electrochemical cell.

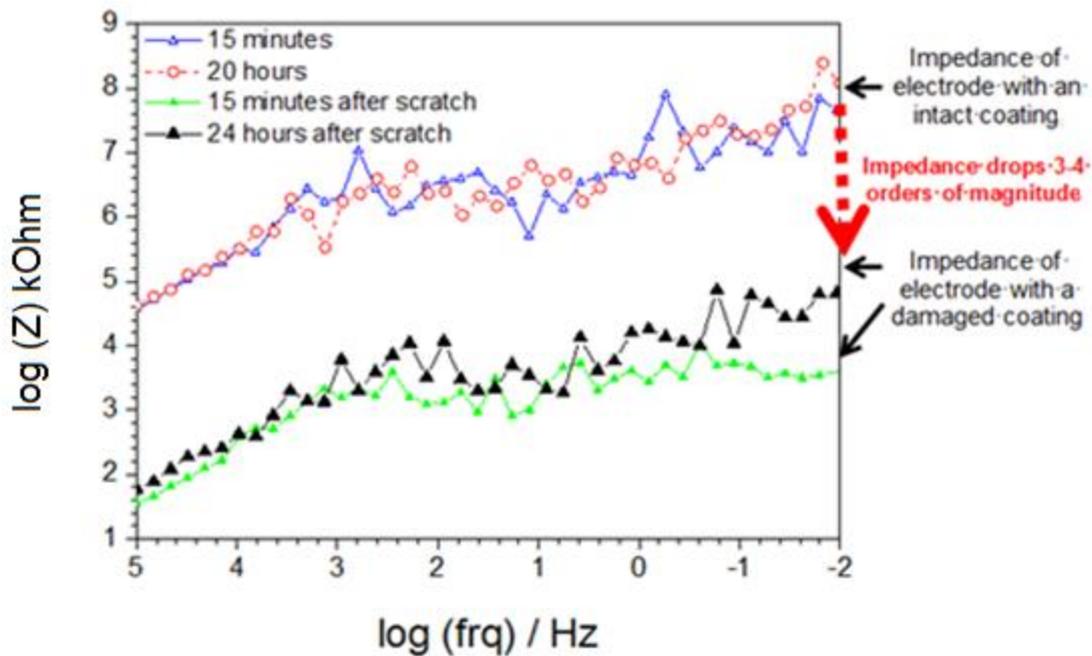
Figure 4. EIS Bode plots collected upon epoxy coated X70 steel specimens (under CP) with and without a scratch. A flat cell, incorporating an Ag/AgCl reference electrode and a titanium mesh counter electrode was used to carry out EIS measurements. Tests were performed in 0.06 wt.% NaCl solution at an applied potential of  $-1200 \text{ mV}_{\text{Ag/AgCl}}$  [19].

CP excursion towards excessive negative potential could also lead to over-protection and cathodic disbondment of pipeline coatings. Cathodic disbondment is a mode of coating failure that frequently occurs in underground metal structures such as oil and gas pipelines which are protected by organic coatings in conjunction with cathodic protection. It is generally believed that cathodic disbondment of pipeline coatings is due to a strong alkaline environment at the defects in the coating that damages the bonding between coating and metal surface. Traditionally the Direct Current Voltage Gradient (DCVG) is a survey method for detecting defects in the pipeline coating. It is based on the measurement of the potential difference between two reference electrodes placed at a constant distance. It can be performed simultaneously with the Close Interval Potential Surveys (CIPS) hybrid surveys. At the coating holiday locations, due to the lack of a coating acting as a barrier the protective current density increases leading to uneven distribution of current and IR drops. A limitation of these surveys is that they cannot distinguish disbonded coatings from intact coatings. This is due to the fact that in the case of disbonded coatings, the protective current is shielded by the coating film. Developing sensors for monitoring coating degradation, disbondment and local damages is therefore desirable. One of our recent developments is coating assessment based on EIS measurements under CP in a standard three-electrode flat cell (PAR) [19]. As shown in Figure 4, the creation of a small scratch in epoxy coating caused a significant decrease in impedance value (a drop of 2-4 orders of magnitudes). These results indicate that EIS can be carried out under CP potential in highly resistive media and that EIS data could be used to detect coating damage under simulated energy pipeline CP conditions.

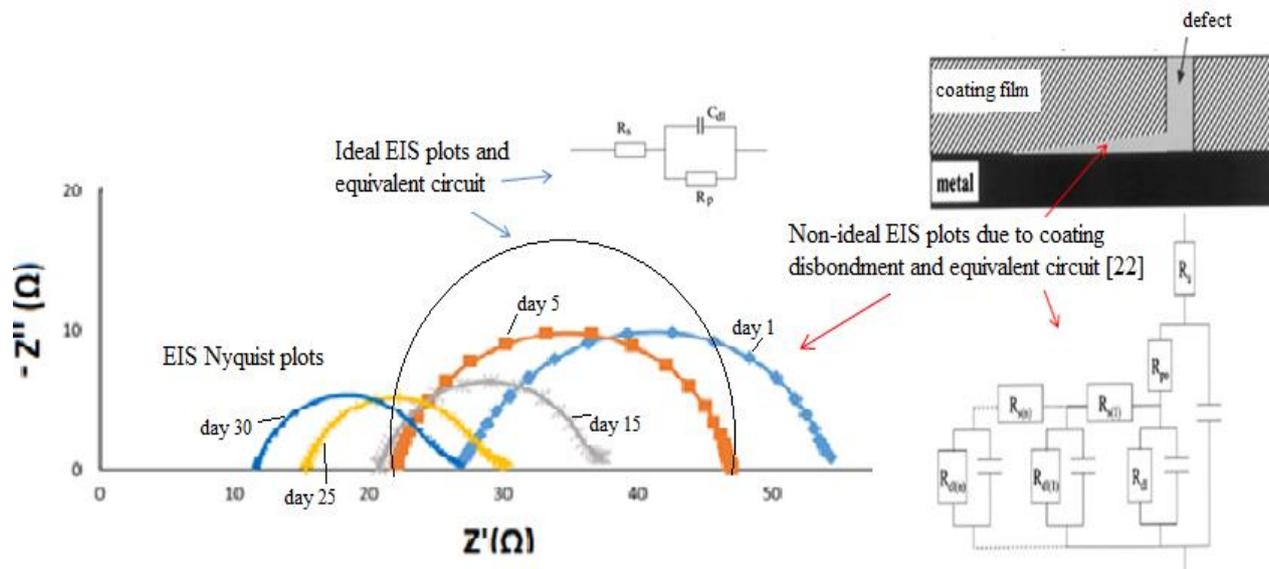
Figure 5. A complex equivalent circuit proposed to fit the ‘non-ideal’ EIS plots measured from electrode with a disbonded coating [22], and a typical set of EIS data obtained after different periods of cathodic disbondment testing using a flat cell, incorporating an Ag/AgCl reference electrode and a titanium mesh counter electrode.

EIS method has also been used for measuring the cathodic disbondment of coatings. Kendig et al. [24] proposed a circuit specifically for a disbonded coating (see Figure 5). They believe once disbonding commences and the coating/metal

interface undergoes hydration and corrosion, cathodic disbonding would proceed from the defect. If the ohmic resistance under the film ( $R_{si}$ ) is relatively large due to a small gap defining the disbondment, then the result may be modeled by a transmission line as shown in Figure 5. Margarit et al. [25] measured EIS of steel electrodes coated with fusion bonded epoxy (500  $\mu\text{m}$ ), low density polyethylene (3000  $\mu\text{m}$ ) and coal tar (3000  $\mu\text{m}$ ) with defects of 6 mm diameter under cathodic protection potential. After exposing the sample to a cathodic potential (-0.85, -1, -1.2 and -1.5 V vs SCE) impedance measurements were performed under the same cathodic potentials. Although the authors asserted that a decrease in the impedance values during exposure time was attributable to the coating disbondment, no quantitative relationship between the delaminated area and the electrochemical parameters was established. Raghunathan [26] in a dissertation reported the results of EIS measurement for prediction of disbondment behavior of fusion bonded epoxy. Steel coated samples with 350  $\mu\text{m}$  thickness and with an artificial defect were kept under a cathodic potential of -3 V versus SCE at 65  $^{\circ}\text{C}$  for 30 days. According to this work, double layer capacitance values derived from EIS data (collected at -1.5 V versus SCE) increased with time during initial days of exposure; however, a drop or plateau behavior was observed afterwards. The in-situ measurement of the cathodic disbondment of thick coatings using EIS under cathodic protection has not been successful to date and no quantitative relationship has been identified between electrochemical parameters and coating disbondment behaviour. In this work EIS was employed to study the cathodic disbondment behavior of a 1000  $\mu\text{m}$  epoxy coating with an artificial defect under an excessive cathodic protection potential.

EIS tests were carried out under applied CP potential conditions. In a typical experiment a sinusoidal potential wave at applied CP potentials (-760 mV or -1200 mV<sub>Ag/AgCl</sub>) with an amplitude of 10 mV was applied to a coated specimen with an artificial defect. Impedance response was measured over frequencies between 10<sup>5</sup> Hz to 10<sup>-2</sup> Hz, recording 10 points per decade of frequency. The most critical step of using EIS is the extraction of useful information from EIS diagrams. An equivalent circuit such as the one shown in Figure 5 is needed to fit the non-ideal EIS plots measured from our experiments in order to extracting useful information related to coating disbondment. By carrying out EIS analysis using the complex equivalent circuit, various parameters including solution resistance ( $R_{\Omega}$ ), double layer capacitance ( $C_{dl}$ ) and polarisation resistance ( $R_p$ ) could be determined. These electrochemical parameters could be correlated to coating disbondment that can be determined based on observation of electrode surface. A typical correlation between electrochemical measurement and coating disbondment observation is shown in Figure 6. Correlation shown in Figure 6 suggests that EIS analysis could provide in-situ information on the processes of cathodic disbondment occurring at the interface of coating and steel pipeline. Therefore EIS has the potential of monitoring coating disbondment in the field. Results from this latest development will be reported elsewhere. It appears in results although the real disbonded area increased even after day 15 (Fig.4), the decrease in EIS parameters showed a plateauing behaviour from day 15 afterwards. Therefore, day 15 EIS lost its sensitivity to measure the changes in resistance values. A further progress in this research is the combined use of the EIS and the array electrode that could provide more detailed spatial and temporal information regarding coating disbondment processes.

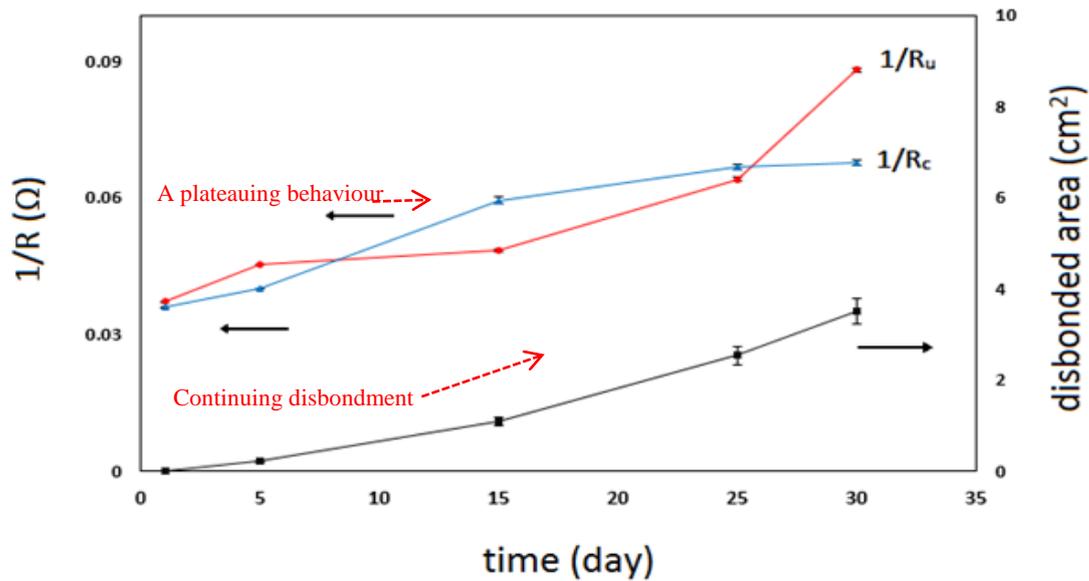
Figure 6. Correlation between charge transfer and uncompensated resistances and disbonded area against time for coated steel during 30 days exposure under  $-1.4 \text{ V}_{\text{Ag}/\text{AgCl}}$  CP potential.
