## **Capabilities and limitations of direct current and electrochemical impedance mapping in measuring cathodic disbondment of coatings using multi-electrode array**

# CAPABILITIES AND LIMITATIONS OF DIRECT CURRENT AND ELECTROCHEMICAL IMPEDANCE MAPPING IN MEASURING CATHODIC DISBONDMENT OF COATINGS USING MULTI-ELECTRODE ARRAY

F. Mahdavi, M.YJ. Tan, M. Forsyth  
Institute for Frontier Materials and School of Engineering, Deakin  
University, Victoria 3216, Australia,

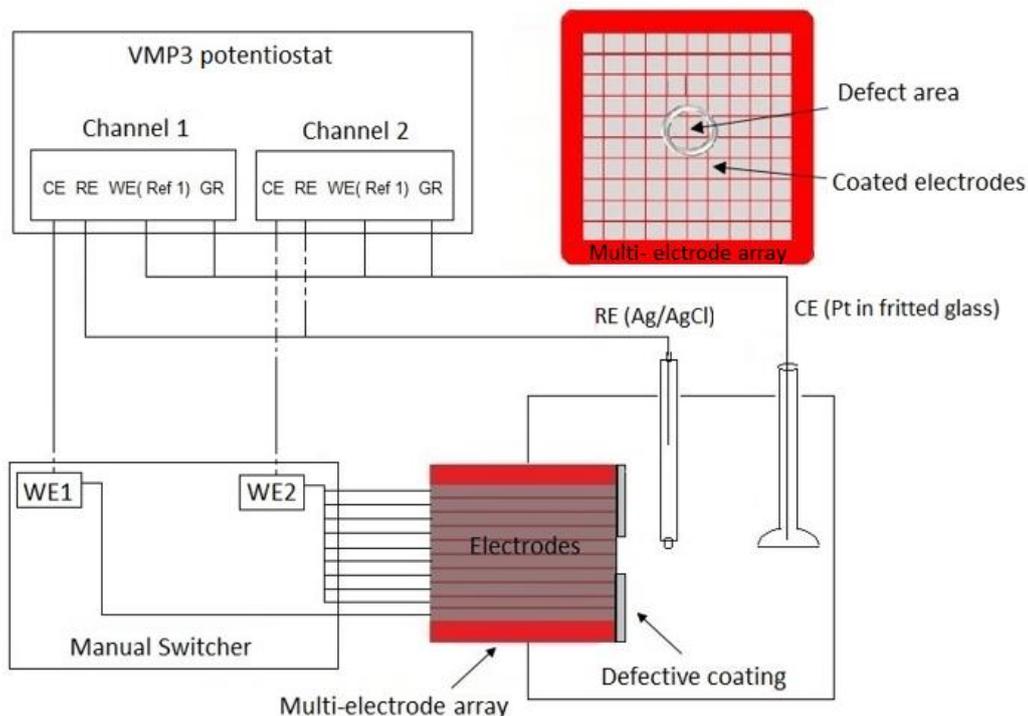
Figure 1 Schematic diagram of the experimental setup for local EIS measurement under CP

The schematic of the employed multi-electrode array (custom-made by Proficiency Contracting Pty. Ltd) with a slight modification to the old generation of multi-electrode array is shown in Figure 1. The multi-electrode array consists of 100 closely packed (gap size:  $0.10 \pm 0.05$  mm) and isolated square shaped electrodes of carbon steel 1020 (2.44 mm x 2.44 mm). The terminals of the wire bundle can be connected together to simulate a one piece electrode. The working surface of the array electrode was polished using 600 and 1200 grit SiC paper and was washed with acetone. The transparent polyester coating (Barnes Products Pty. Ltd.) was prepared by mixing unsaturated polyester resin with 1 wt.% methyl ethyl ketone peroxide (MEKP) as a curing catalyst. The coating was applied on top of a sample of multi-electrode array by brushing. Coated sample was dried at room temperature for 7 days. The measured dry film thickness using a digital Elcometer thickness gauge was  $1000 \pm 20$   $\mu\text{m}$ . An artificial defect of 5 mm diameter was drilled at the center of the coated samples by flat ended bit to reach the metal surface. The coated multi-electrode array was inserted and fixed into an electrochemical cell that was filled with aqueous solution of 3 wt.% NaCl solution. Potential of  $-1400$  mV<sub>Ag/AgCl</sub> was applied to the sample using a VMP3-300 potentiostat (Bio-Logic Science Instruments) through a platinum wire inserted in a fritted glass with pore size of 10-15 micron as counter electrode. During application of the CP potential the electrodes were connected at the terminals through a connector. Sample was exposed to solution under CP for 600 hours.

As shown in Figure 1, to perform in-situ local EIS measurement on each electrode, the terminal of the array electrode was connected to a manual switcher enabling the measurement of EIS on each of the electrodes (as WE1 in Figure 1), while it was disconnected from the other 99 coupled electrodes (as WE2). In order to perform an in-situ EIS measurement on WE1 and simultaneously controlling the CP potential on the WE2, two potentiostat channels of the VMP3 instrument (Bio-Logic Scientific) in CE to ground connection mode was used (details of connections elaborated in Figure 1). Using channel 1, the same CP potential as test potential is applied to WE1 until the response current is stable, following by measuring EIS at the same CP potential. Simultaneously, CP was applied to WE2 to ensure cathodically protecting rest of 99 electrodes. The EIS was measured with a perturbation potential of  $\pm 10$  mV in the frequency range of 100 KHz to 300 mHz.

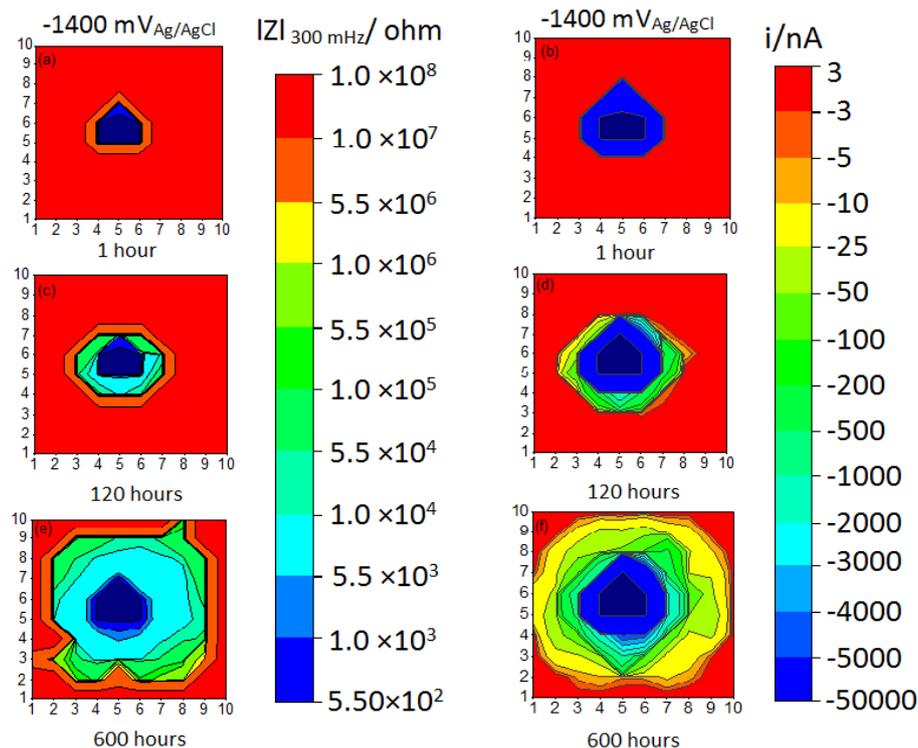
Figure 2 Maps of electrochemical impedance : (a, c, e) and direct current (b, d, f) measured at CP potential of  $-1400 \text{ mV}_{\text{Ag/AgCl}}$  on coated multi-electrode array after with a defect after 1, 120 and 600 hours exposure to solution with resistivity of 20 ohm.cm.

Figure 2 shows the maps of amplitude of electrochemical impedance ( $|Z|_{300\text{MHz}}$ ) and maps of current distribution (i) which were obtained by means of measuring the local parameters at CP potential of  $-1400$  mV<sub>Ag/AgCl</sub> over the coated multi-electrode array during different exposure of sample to solution with resistivity of 20 ohm.cm under CP potential.

It is clear that the current and impedance maps measured after 1 hour exposure (Figure 2) are characterized with a small area at the centre of maps with current values more negative than  $-3 \text{ nA}$  and impedance values  $< 1 \times 10^2 \text{ ohm}$  correlating to electrochemical activity of metal surface of defect area. The defect is surrounded with areas of high impedance  $> 1 \times 10^7 \text{ ohm}$  and very small current values close to zero, which are related to areas with intact coating. By extending the exposure time to 120 hours the impedance values on sites around the defect area drop to values between  $1 \times 10^7 \text{ ohm}$  and  $5.5 \times 10^3 \text{ ohm}$  (Figure 2c) along with forming similar sites on current maps with values more negative than  $-3 \text{ nA}$  (Figure 2d); these areas form around the defect upon cathodic disbondment of coating and access of solution to metal surface through disbonded gap between coating and metal surface. By extending the exposure time to 600 hours the propagation of disbonded area is elaborated on maps of current and impedance (Figure 2e and Figure 2f). These results clearly indicate that both techniques of electrochemical impedance and current mapping performed at CP potential of  $-1400 \text{ mV}_{\text{Ag/AgCl}}$  while exposure to a solution with low resistivity (20 ohm.cm) are efficient in detecting and monitoring the cathodic disbondment of coating.

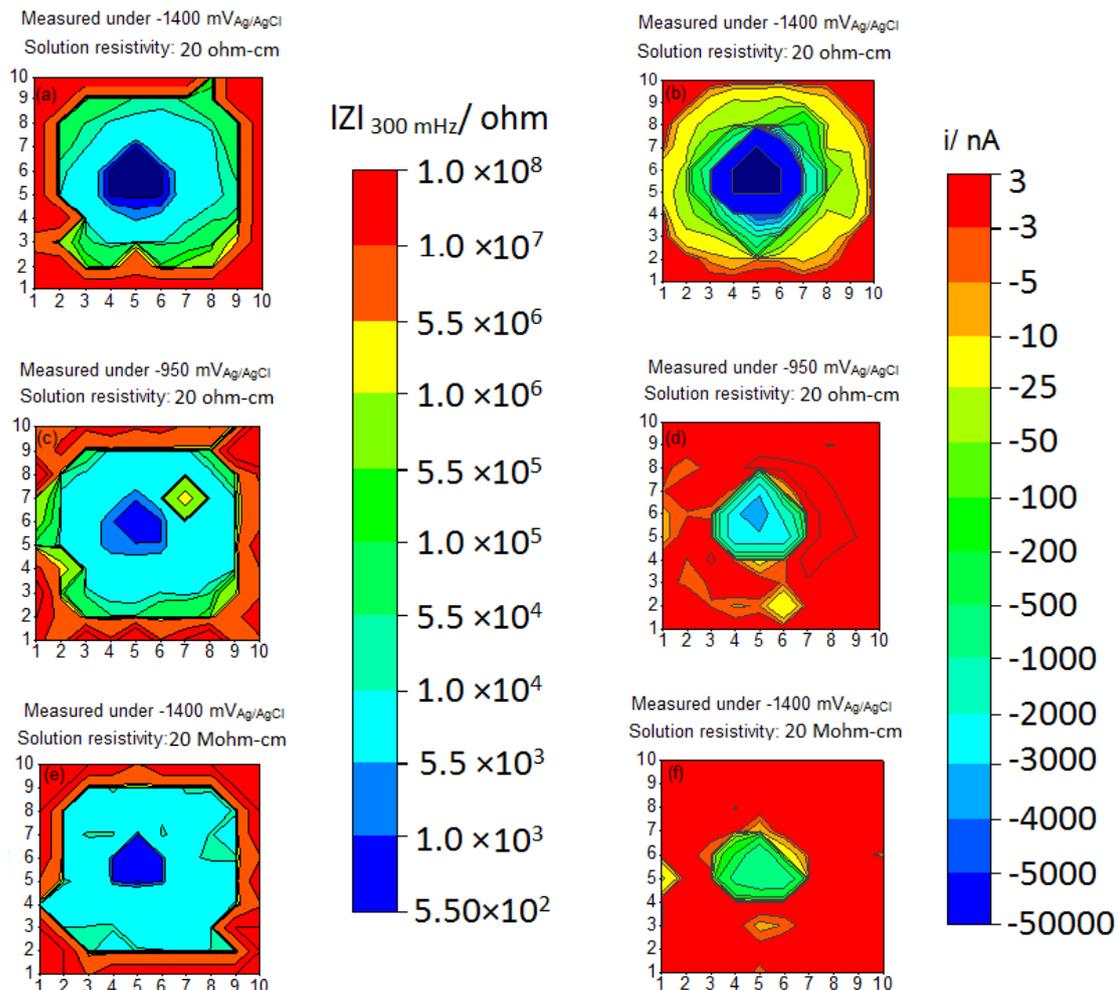
Figure 3 Maps of electrochemical impedance and direct current measured over coated multi-electrode array after 600 hours measured under  $-1400 \text{ mV}_{\text{Ag}/\text{AgCl}}$  while exposure to a solution with resistivity of  $20 \text{ ohm.cm}$  (a, b); measured under  $-950 \text{ mV}_{\text{Ag}/\text{AgCl}}$  while exposure to a solution with resistivity of  $20 \text{ ohm.cm}$  (c, d); measured under  $-1400 \text{ mV}_{\text{Ag}/\text{AgCl}}$  while exposure to a solution with resistivity of  $20 \text{ Mohm.cm}$  (e, f).

In order to understand the performance of these techniques in different exposure environments and under different CP conditions, the disbonded area on the sample with disbonded coating after 600 hours was evaluated by measuring local impedance and current at CP potential of  $-950 \text{ mV}_{\text{Ag/AgCl}}$  while keeping the sample exposed to solution with resistivity of 20 ohm.cm (Figure 3c and Figure 3d) and also by measuring both electrochemical impedance and current on sample at  $-1400 \text{ mV}_{\text{Ag/AgCl}}$  while exposure to solution with a high resistivity of 20 Mohm.cm (Figure 3e and Figure 3f). These results can be compared easily with the former measurement performed at potential of  $-1400 \text{ mV}_{\text{Ag/AgCl}}$  while exposure to low resistivity solution of 20 ohm.cm (Figure 3a and Figure 3b).

Comparing the maps obtained by means of local measurements under different conditions have shown that the current maps measured at lower CP potential of  $-950 \text{ mV}_{\text{Ag/AgCl}}$  in lower solution resistivity and also the current

maps measured at higher CP potential of  $-1400 \text{ mV}_{\text{Ag}/\text{AgCl}}$  in higher solution resistivity are characterized with major areas with current values  $< -3 \text{ nA}$  (Figure 3d and Figure 3f). This means that although according to current and impedance maps of Figure 3a and Figure 3b, most parts of polyester coated electrode has been disbonded during 600 hours of exposure, current mapping at lower CP potential and higher solution resistivity did not correlate with the cathodic disbondment area of the coating accurately. On the other hand, the electrochemical impedance mapping measured at the same conditions of lower CP potential and higher solution resistivity (Figure 3c and Figure 3e) were successful in accurately evaluating of disbonded area of sample.
