CP PERMEABLE COATING AND CORROSION UNDER DISBONDED COATINGS

M. Latino¹, F. Varela¹, Y. Tan¹ and M. Forsyth¹

¹Deakin University, Geelong, Australia, Institute for Frontier Materials and School of Engineering

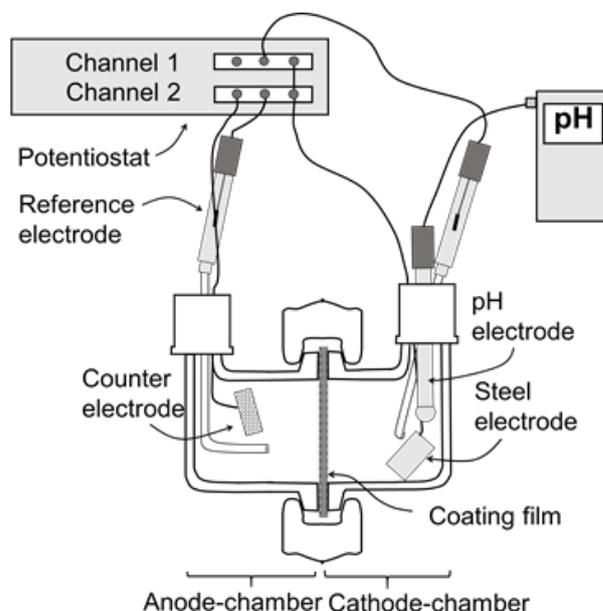
The experimental setup consisted of a glass double-chamber cell with electrodes, filled with 0,1 M NaCl aqueous solution and separated by thin films. A schematic of the setup is shown in Figure 1. A cathode-chamber of 30 ml of volume was used to study the environment under coating disbondment. It contained a pipeline steel working electrode, a Lugging capillary connected to a Ag|AgCl/KCl (sat.) reference electrode to measure the true polarisation of the steel, a combination-type pH electrode with an internal double junction Ag|AgCl gel reference to measure the pH of the solution in contact with the steel. The steel electrode was obtained from the external diameter of an X65 grade pipeline. It had an exposed area of 1.5 cm² and the electrical contact and sides were covered with cold mounting epoxy resin. The surface of the electrode was sanded with a 220 grit paper and rinsed with ethanol.

Figure 1 Schematic cross sectional view of the experimental setup

A high sensitivity potentiostat and a Faraday cage were used for the experiments. A three-electrode configuration was selected for the application of CP and measurement of current through the coating using "Channel 2" as shown in Figure 1. Constant CP potentials equivalent to -850 mV, -1050 mV and -1250 mV vs. Cu|CuSO₄ were applied during the tests for the periods of time indicated alternating with periods of open circuit potential (OCP). The true polarisation of the steel electrode was continuously measured with an independent potentiostat, named as per "Channel 1" in Figure 1.

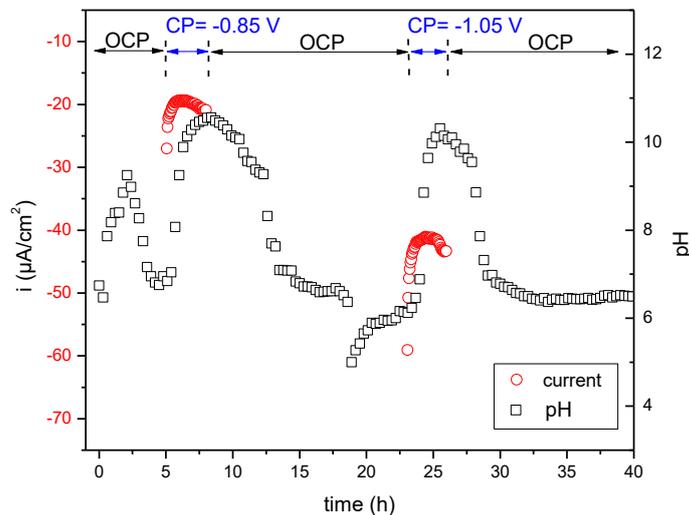
Measurements of current densities and pH for alternated periods of OCP and CP application on a steel electrode in a testing cell without a coating film are shown in Figure 2. Current densities are in the range of $20 \mu\text{A}/\text{cm}^2$ and $40 \mu\text{A}/\text{cm}^2$ for CP equal to -850 mV and -1050 mV , respectively. The pH in the neighbourhood of the steel cathode increases above nine units upon CP application; this value is maintained for about five hours and then the pH quickly returns to a near neutral value in the next five hours.

Figure 2 - current density and local pH measurements for a cell in absence of a coating barrier

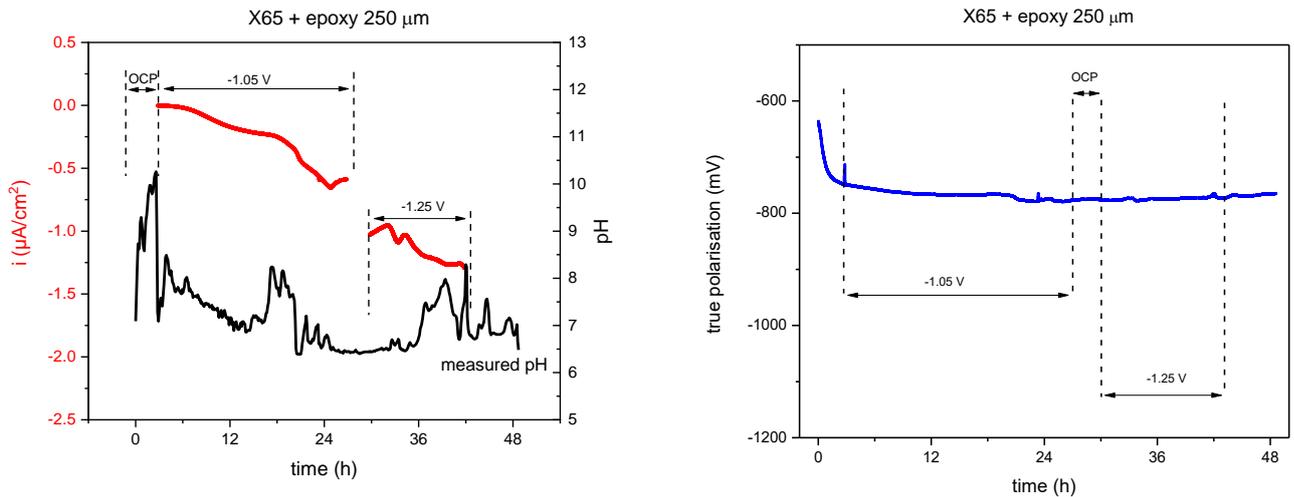
Results of the current conducted through epoxy coatings for different CP potentials, and local pH in the cathode chamber are shown in Figure 3 (left). The cathodic current densities measured through the coatings are smaller than $1 \mu\text{A}/\text{cm}^2$ during the first day slightly exceeding this value when CP is increased to -1.25 V . The pH in the cathode cell does not exhibit a notorious last-standing increase during the test. Only short periods of alkalinity increase to values around eight pH units were observed upon CP application quickly returning to near neutral pH values. The true polarisation of the steel electrode in the cathode chamber is presented in Figure 3 (right). No apparent instant polarisation shifts were observed when applying different CP potentials or when CP was disconnected. After finalising the experiment, a CP of -850 mV was applied over a week. Corrosion products became noticeable after a few days testing. As an example, Figure 4 shows the presence of reddish corrosion products suspended in solution and on the steel electrode's surface after a week of CP application of -850 mV .

Figure 3 - Experiments for steel cathode subjected to alternated cycles of OCP, CP= -1.05 V vs. Cu|CuSO₄ and CP= -1.25 V vs. Cu|CuSO₄. Left: current density conducted through a 250 μm field joint epoxy coating and local pH under simulated disbonded coating. Right: true polarisation of X65 under simulated disbonded coating.

Results in Figure 3 indicate that direct protection by polarisation to the desired potential of -850 mV vs. Cu|CuSO₄ was not achieved efficiently. Applying a CP potential of -1.25 V did not affect significantly the true polarisation of the steel. The reason for this is that, despite the coating allows conduction of CP current, it still represents a physical barrier limiting the amount of ions passage. This can also be inferred when comparing the small current measured through coating with the current necessary to polarise a steel electrode up to the desired potentials in Figure 2. While the current necessary to polarise the steel electrode to approximately -1.05 V would be of about -40 μA/cm², the presence of a coating barrier limits the transported current to a fraction of a μA/cm². Therefore, such magnitude of current would be insufficient to effectively counteract the anodic reactions happening on the steel surface and the metal would consequently corrode. These results suggest that even though the thin coating allowed the conduction of CP, the amount of currents conducted upon the different CP levels applied would be insufficient to protect effectively the underlying metal by electrochemical polarisation.

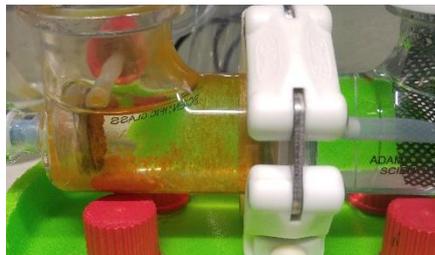
Figure 4 – appearance of a cathode chamber after one week testing under CP= -0.85 V

with the metal and decrease the pH. The presence of orange-reddish precipitates shown in Figure 4 indicates the formation of iron products, which would support the latter statement.

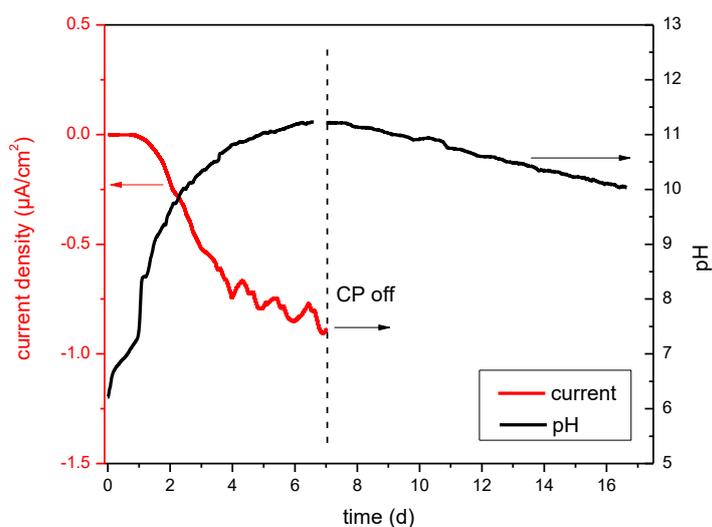
This reaction in Eqn 1 could lead to alkalinisation of the solution due to the generation of hydroxyl ions. This was the case observed in previously conducted research [17] when using an inert cathode such as titanium-mix-oxide. Previous results reproduced in Figure 5 show a significant alkalinisation in the cell simulating the coating disbondment mainly because the cathode would not present anodic reactions and the measured current would translate into generation of hydroxyl ions. However, when the cathode is made of steel, the pH is maintained around near neutral values. A plausible explanation for the near neutral pH values observed in the experiment in Figure 3 could be due to the complex formation of iron corrosion products that follow a non-stoichiometric relationship with OH⁻ consumption. Such products would remove hydroxyl ions from the environment in contact

Figure 5 – pH and current through a 280 μm field joint epoxy under CP of -850 mV vs. Cu|CuSO₄ using an inert cathode. Data was extracted from [17]

It would be natural to think that hydroxyl ions movement through a semipermeable coating could also lower the pH. However, the test using an inert cathode in Figure 5 demonstrated that the coating would be able to retain a high pH environment after disconnection of CP, i.e. only a decrease of less than a pH unit was observed after seven days without CP. This slight decrease in pH in the cathode chamber may be explained as per either inwards diffusion of protons or outwards diffusion of hydroxyl ions, or both. Although this effect was noticeable, it demonstrated to be second order of importance in comparison with consumption of hydroxyl ions as per reactions discussed above.
